**Flood Control Project Maintenance  
Levee Inspections**

**Fall 2016 Levee Maintenance Deficiency Summary Report**

**Sacramento River Basin**

<b>ST0003</b>	Overall LMA Rating	Total LMA Miles	* Overall LMA Threshold Percent is less than 10.00%; however, U Rated Miles are present, so the Overall LMA Rating is M instead of A.					
<b>Sutter Maintenance Yard East Levee Sacramento River</b>	<b>M *</b>	<b>26.82</b>						
Rated Item	Maintenance Deficiency				Enforcement		Design & System Obsolescence	
	M Miles	U Miles	M + 4U Miles	Threshold %	M Miles	U Miles	M Miles	U Miles
<i>Earthen Levee</i>								
Vegetation	0.83		0.83	3.10%	0.01			
Trim / Thin Trees	0.07		0.07	0.26%				
Encroachments					1.83	0.06		
Animal Control	0.08	0.01	0.12	0.45%				
Slope Stability	0.05		0.05	0.19%				
Erosion / Bank Caving	0.02		0.02	0.08%				
<i>Supplemental</i>								
2015 USACE Erosion Survey, DRAFT	0.36		0.36	1.34%				
DWR UCIP Field Study					0.38	0.11		
<i>LMA Totals:</i>	1.41	0.01	1.45	5.41% *	2.22	0.17	0.00	0.00
<b>Unit No. 01 Sacramento River LB</b>	Overall Unit Rating	Total Unit Miles	* Overall Unit Threshold Percent is less than 10.00%; however, U Rated Miles are present, so the Overall Unit Ra

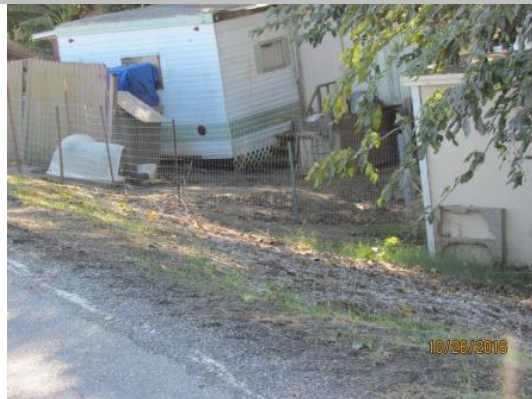
Photo 1 of 1 : FA\_2016\_ST0003\_264\_3\_20161104\_00122.jpg

View of the trailers and building on the waterside.

LM Start	0.24	Rating **	M	Issue No.	82
LM End	0.24	Issue Type +	Ma	Location *	WS
Category	Earthen Levee			GPS Latitude/Longitude	
				Start	End
Item	Slope Stability			39.195234 °	39.195234 °
				-121.939124 °	-121.939124 °
DWR ID	DWR_ST0003_01_f _2016_82				
Comment Code					
S3 : Repair the levee slope damaged by vehicle traffic and prevent access where possible.					
Inspector Comment

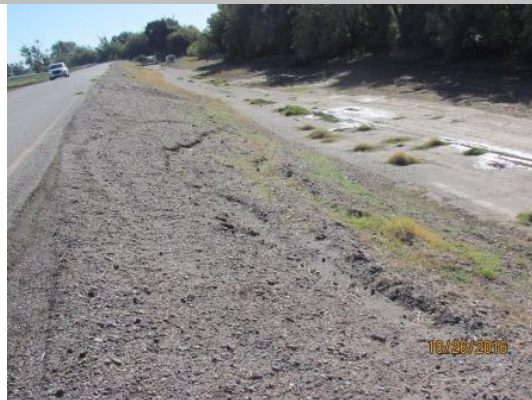
Photo 1 of 1 : FA\_2016\_ST0003\_264\_81\_20161104\_00123.jpg

LM Start	0.42	Rating **	M	Issue No.	81
LM End	0.42	Issue Type +	Ma	Location *	WS
Category	Earthen Levee			GPS Latitude/Longitude	
				Start	End
Item	Slope Stability			39.196483 °	39.196483 °
				-121.942228 °	-121.942228 °
DWR ID	DWR_ST0003_01_f_2016_81				
Comment Code					
S3 : Repair the levee slope damaged by vehicle traffic and prevent access where possible.					
Inspector Comment

View of the ruts along the waterside slope.

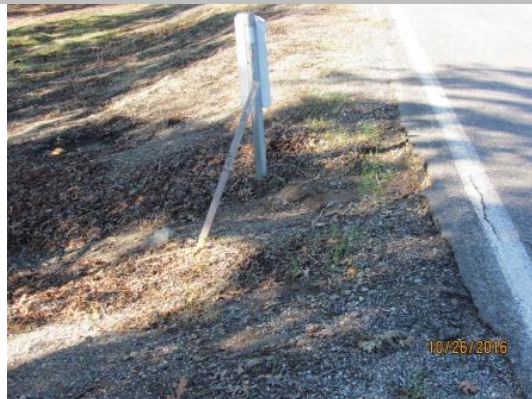
Photo 1 of 1 : FA\_2016\_ST0003\_264\_80\_20161104\_00124.jpg

LM Start	1.17	Rating **	M	Issue No.	80
LM End	1.17	Issue Type +	Ma	Location *	WS
Category	Earthen Levee			GPS Latitude/Longitude	
				Start	End
Item	Slope Stability			39.194126 °	39.194126 °
				-121.953345 °	-121.953345 °
DWR ID	DWR_ST0003_01_f_2016_80				
Comment Code					
S1 : Repair slope instability.					
Inspector Comment

View of the slope instability along the waterside slope.

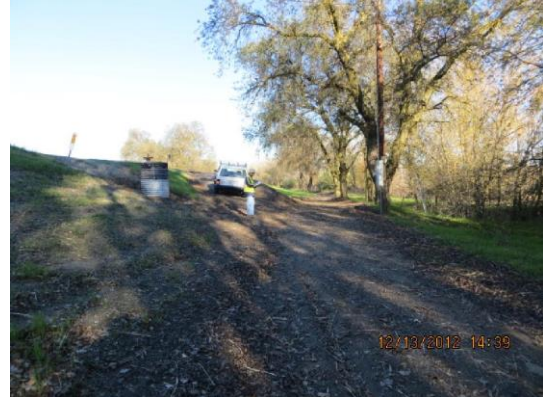
Photo 1 of 2 : UCIP\_FA\_2016\_50629\_46983.jpg

FS\_ID:50629  
DS\_ID:17319  
EP\_NO: 9527  
Repair Type: Urgent  
Crossing Status: Found  
UCIP Comments: 11/7/2016 No LS repairs have been made yet. (DWR Sutter Yard- AFreitag)6/6/2016 New flow meter installed on WS. Walkway to access the pump is overgrown with vegetation and not accessible. (DWR Sutter Yard - afreitag) 4/5/2016 Caved-in slope on landside (LS) not yet repaired. Leaky pipe marker gone. Per Bob Duffey (DWR FPIIB inspector), pipe will be replaced by owner next year. If not, will go to CVFPB enforcement. (DWR UCIP - kfazel)4/6/2015 Pipe leaks during times of High water. Slope damage still present. Needs a more detailed inspection to find the leak. (DWR Sutter Yard - afreitag)6/30/2014 Same as last inspection. (DWR Sutter Yard - afreitag)12/30/2013 Same as last inspection. (DWR Sutter Yard - afreitag)7/29/2013 Pipe does not appear to be abandoned. On the WS it appears that a smaller pipe was sleeved into the 18in. Pipe and then the difference capped and welded. Pump was not running at time of inspection but LS ditch near outlet was wet. LS slope damage and leaky pipe marker are still present. (DWR Sutter Yard - afreitag)12/13/2012 Abandoned and plugged/capped steel pipe on WS berm. DWR leaky pipe marker on LS (12-3). Slope failure on LS. Needs capping of LS steel pipe after detailed investigation. (DWR UCIP - pamatya)

Waterside view: overview

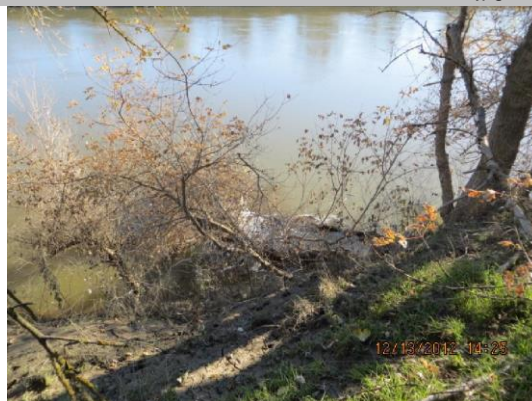
Photo 1 of 2 : UCIP\_FA\_2016\_50630\_46992.jpg

FS\_ID:50630  
DS\_ID:17320  
EP\_NO: 9543  
Repair Type: Urgent  
Crossing Status: Found  
UCIP Comments: 11/7/2016 No repairs have been made here yet. (DWR Sutter Yard- AFreitag)6/17/2016 River levels were down and the WS pipe end was exposed. WS end is completely rotten and damaged and flap gate has fallen off the end of the pipe (see pics). Pipe needs to be replaced or repaired. (DWR Sutter Yard - afreitag)4/5/2016 Erosion on WS slope still present. Pipe still fully submerged on WS and discharging into river during site visit. (DWR UCIP - kfazel)4/6/2015 Pipe leaks during high water. DWR employee said he suspects that the flap gate has rotted and fallen off WS end of pipe. Could not locate WS end of pipe to confirm. Water was flowing through this drain during field survey. (DWR Sutter Yard - afreitag)6/30/2014 Same as last inspection. (DWR Sutter Yard - afreitag)12/30/2013 Same as last inspection. (DWR Sutter Yard - afreitag)7/29/2013 Same as last inspection. (DWR Sutter Yard - afreitag) 12/13/2012 Water was flowing through this drain during field survey. (DWR UCIP - pamatya)

FIELD\_STRUCT\_DESC: 30-inch corrugated metal drainage pipe (at 45 degrees) through the levee, 25.2 feet below the crown. Flap gate on the waterside (WS), not found in 2016. (Automatic Board Order (ABO) issued as Permit No. 9543, 1974 - Harada). [Additional Reference(s): DWR Levee Log, 2002. USACE Sacramento O&M Manual 136, revision March 1960 (HLM 1.38)]  
FS Date: 11/7/2016 2:38:27 PM

Waterside view: overview of river bank

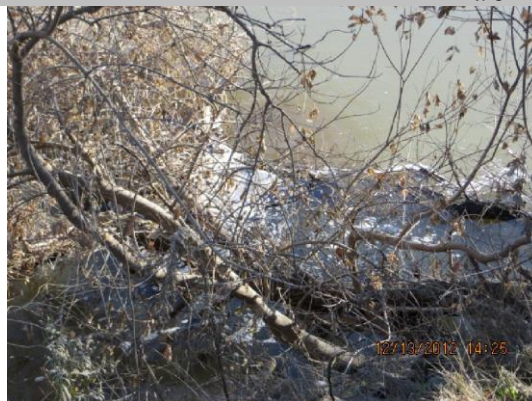
Photo 2 of 2 : UCIP\_FA\_2016\_50630\_46991.jpg

Item	DWR UCIP Field Study			39.192502 °	39.192502 °	
				-121.958062 °	-121.958062 °	
DWR ID						
Comment Code						
Inspector Comment						
FS_ID:50630 DS_ID:17320 EP_NO: 9543 Repair Type: Urgent Crossing Status: Found UCIP Comments: 11/7/2016 No repairs have been made here yet. (DWR Sutter Yard- AFreitag)6/17/2016 River levels were down and the WS pipe end was exposed. WS end is completely rotten and damaged and flap gate has fallen off the end of the pipe (see pics). Pipe needs to be replaced or repaired. (DWR Sutter Yard - afreitag)4/5/2016 Erosion on WS slope still present. Pipe still fully submerged on WS and discharging into river during site visit. (DWR UCIP - kfazel)4/6/2015 Pipe leaks during high water. DWR employee said he suspects that the flap gate has rotted and fallen off WS end of pipe. Could not locate WS end of pipe to confirm. Water was flowing through this drain during field survey. (DWR Sutter Yard - afreitag)6/30/2014 Same as last inspection. (DWR Sutter Yard - afreitag)12/30/2013 Same as last inspection. (DWR Sutter Yard - afreitag)7/29/2013 Same as last inspection. (DWR Sutter Yard - afreitag) 12/13/2012 Water was flowing through this drain during field survey. (DWR UCIP - pamatya) FIELD_STRUCT_DESC: 30-inch corrugated metal drainage pipe (at 45 degrees) through the levee, 25.2 feet below the crown. Flap gate on the waterside (WS), not found in 2016. (Automatic Board Order (ABO) issued as Permit No. 9543, 1974 - Harada). [Additional Reference(s): DWR Levee Log, 2002. USACE Sacramento O&M Manual 136, revision March 1960 (HLM 1.38)] FS Date: 11/7/2016 2:38:27 PM

Waterside view: water flowing from outlet pipe (pipe fully submerge)

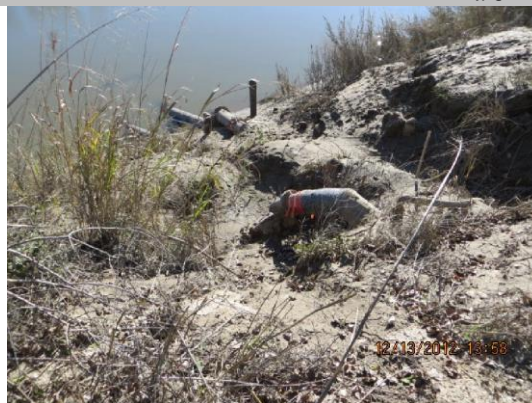
Photo 1 of 2 : UCIP\_FA\_2016\_50631\_46998.jpg

Comment Code					
Inspector Comment					
FS_ID:50631					
DS_ID:17322					
EP_NO: 9258					
Repair Type: Non-Urgent					
Crossing Status: Found					
UCIP Comments: 11/7/2016 WS riser still full of soil. No pump present					
and 10" pipe left opened on the WS. (DWR Sutter Yard-					
AFreitag)6/17/2016 Same as last inspection. 4/6/2015 CMP riser					
filled with silt/soil on WS. No other issues present.6/30/2014 Same					
as last inspection.12/30/2013 Same as last inspection.7/29/2013					
Same as last inspection.					
FIELD_STRUCT_DESC: 10-inch asphalt coated steel irrigation pipe					
through the levee, 3.7 feet below the crown. Pump installed on the					
waterside (WS). (Permit No. 9258, 1974 - Harada). [Additional					
Reference(s): DWR Levee Log, 2002].					
FS Date: 11/7/2016 2:43:45 PM

Waterside view: overview

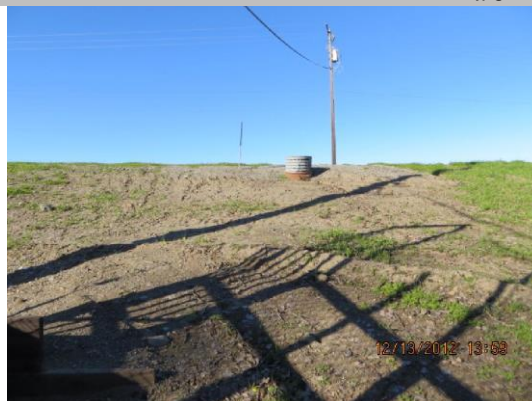
Photo 2 of 2 : UCIP\_FA\_2016\_50631\_46997.jpg

Comment Code					
Inspector Comment					
FS_ID:50631 DS_ID:17322 EP_NO: 9258 Repair Type: Non-Urgent Crossing Status: Found UCIP Comments: 11/7/2016 WS riser still full of soil. No pump present and 10" pipe left opened on the WS. (DWR Sutter Yard-AFreitag)6/17/2016 Same as last inspection. 4/6/2015 CMP riser filled with silt/soil on WS. No other issues present.6/30/2014 Same as last inspection.12/30/2013 Same as last inspection.7/29/2013 Same as last inspection. FIELD_STRUCT_DESC: 10-inch asphalt coated steel irrigation pipe through the levee, 3.7 feet below the crown. Pump installed on the waterside (WS). (Permit No. 9258, 1974 - Harada). [Additional Reference(s): DWR Levee Log, 2002]. FS Date: 11/7/2016 2:43:45 PM

Waterside view: overview of CMP riser

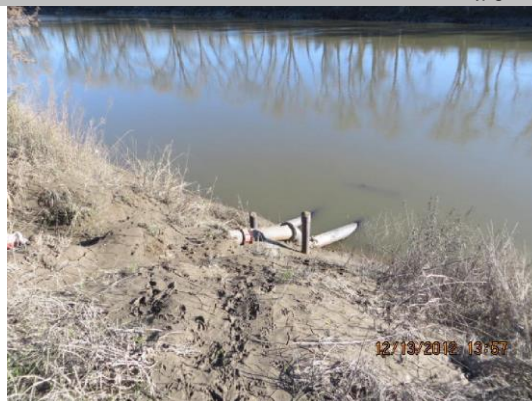
Photo 1 of 2 : UCIP\_FA\_2016\_50632\_47004.jpg

FS\_ID:50632  
DS\_ID:17321  
EP\_NO: 9543  
Repair Type: Urgent  
Crossing Status: Found  
UCIP Comments: 11/7/2016 Abandoned. (DWR Sutter Yard - A Freitag) 6/17/2016 Abandoned crossing. (DWR Sutter Yard - A Freitag) 4/5/2016 Appears abandoned and should be done so properly. LS levee slope has a slight but sudden drop (could be due to improper compaction). Dense vegetation on LS prevented visibility of sloughing or other damage to levee. Could not locate leaky pipe marker. Per Bryan Reniff of Sutter Yard, marker was previously installed due to a high water event, not leaky pipe. Appears repair work to levee performed but unclear of extent. Gate valve on WS is bent and damaged, appears abandoned. Crossing a good candidate for video inspection. (DWR UCIP - kfazel) 4/6/2015 Sloughing LS slope and river bank. DWR marking for leaky pipe. (DWR Sutter Yard - A Freitag) 6/30/2014 Same as last inspection. (DWR Sutter Yard - A Freitag) 12/30/2013 Same as last inspection. (DWR Sutter Yard - A Freitag) 7/29/2013 Same as last inspection. (DWR Sutter Yard - A Freitag) 12/13/2012 Sloughing LS slope and river bank. DWR marking for leaky pipe. (DWR UCIP - pamatya)

Waterside view: pipe @river bank

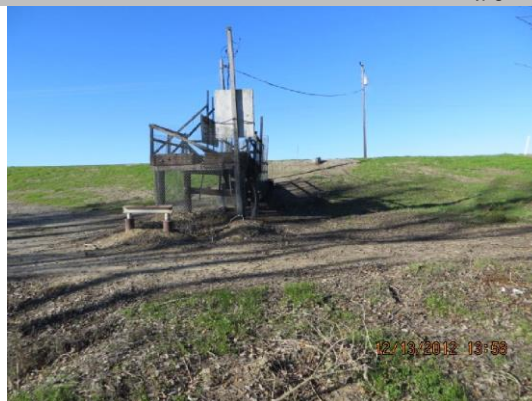
Photo 2 of 2 : UCIP\_FA\_2016\_50632\_47003.jpg

FS\_ID:50632  
DS\_ID:17321  
EP\_NO: 9543  
Repair Type: Urgent  
Crossing Status: Found  
UCIP Comments: 11/7/2016 Abandoned. (DWR Sutter Yard - A Freitag) 6/17/2016 Abandoned crossing. (DWR Sutter Yard - A Freitag) 4/5/2016 Appears abandoned and should be done so properly. LS levee slope has a slight but sudden drop (could be due to improper compaction). Dense vegetation on LS prevented visibility of sloughing or other damage to levee. Could not locate leaky pipe marker. Per Bryan Reniff of Sutter Yard, marker was previously installed due to a high water event, not leaky pipe. Appears repair work to levee performed but unclear of extent. Gate valve on WS is bent and damaged, appears abandoned. Crossing a good candidate for video inspection. (DWR UCIP - kfazel) 4/6/2015 Sloughing LS slope and river bank. DWR marking for leaky pipe. (DWR Sutter Yard - A Freitag) 6/30/2014 Same as last inspection. (DWR Sutter Yard - A Freitag) 12/30/2013 Same as last inspection. (DWR Sutter Yard - A Freitag) 7/29/2013 Same as last inspection. (DWR Sutter Yard - A Freitag) 12/13/2012 Sloughing LS slope and river bank. DWR marking for leaky pipe. (DWR UCIP - pamatya)

Waterside view: abandoned pump station.

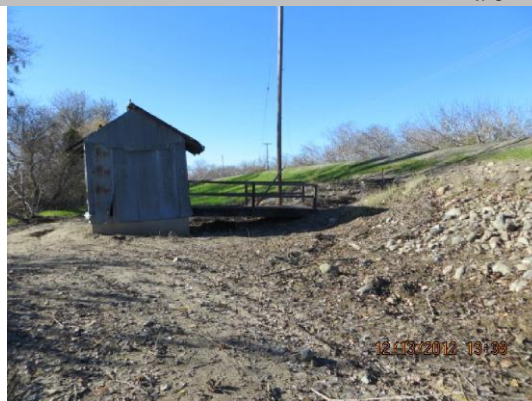
Photo 1 of 2 : UCIP\_FA\_2016\_50633\_47013.jpg

Comment Code					
Inspector Comment					
FS_ID:50633 DS_ID:17305 EP_NO: 9541 Repair Type: Non-Urgent Crossing Status: Found UCIP Comments: 11/7/2016 Abandoned. (DWR Sutter Yard-AFreitag)6/6/2016 Abandoned crossing. Should be properly abandoned.4/6/2015 Same as last inspection. CMP standpipe with gate valve. Abandoned pump house. Pipe discharges into open ditch at landward toe- not found.6/30/2014 Same as last inspection.12/30/2013 Same as last inspection.7/29/2013 Same as last inspection. FIELD_STRUCT_DESC: *ABANDONED* 24-inch irrigation pipe of an unknown material through the levee, 13.5 feet below the crown. Pump in a metal house on the WS (waterside) berm. Slide gate in a corrugated metal pipe riser on the WS slope. Service pole and guy wire anchor on the WS slope. (Automatic Board Order (ABO) issued as Permit No. 9541, 1974 - Wilbur, McGowan, Zinke). [Additional Reference(s): DWR Levee Logs, 2002. USACE Sacramento O&M Manual 136, March 1960 (HLM 2.01)]. FS Date: 11/7/2016 2:56:05 PM

Waterside view: overview

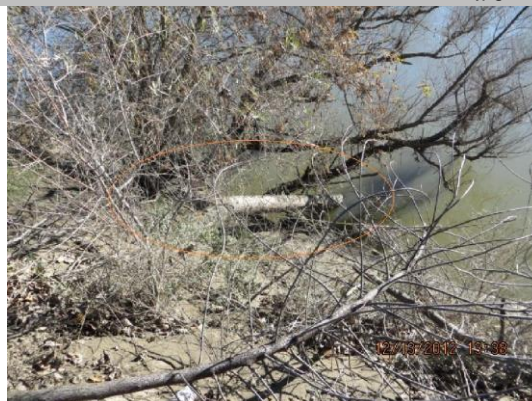
Photo 2 of 2 : UCIP\_FA\_2016\_50633\_47011.jpg

Item	DWR UCIP Field Study			39.187717 °	39.187717 °	
				-121.967712 °	-121.967712 °	
DWR ID						
Comment Code						
Inspector Comment						
FS_ID:50633 DS_ID:17305 EP_NO: 9541 Repair Type: Non-Urgent Crossing Status: Found UCIP Comments: 11/7/2016 Abandoned. (DWR Sutter Yard-AFreitag)6/6/2016 Abandoned crossing. Should be properly abandoned.4/6/2015 Same as last inspection. CMP standpipe with gate valve. Abandoned pump house. Pipe discharges into open ditch at landward toe- not found.6/30/2014 Same as last inspection.12/30/2013 Same as last inspection.7/29/2013 Same as last inspection. FIELD_STRUCT_DESC: *ABANDONED* 24-inch irrigation pipe of an unknown material through the levee, 13.5 feet below the crown. Pump in a metal house on the WS (waterside) berm. Slide gate in a corrugated metal pipe riser on the WS slope. Service pole and guy wire anchor on the WS slope. (Automatic Board Order (ABO) issued as Permit No. 9541, 1974 - Wilbur, McGowan, Zinke). [Additional Reference(s): DWR Levee Logs, 2002. USACE Sacramento O&M Manual 136, March 1960 (HLM 2.01)]. FS Date: 11/7/2016 2:56:05 PM

Waterside view: overview of pipe

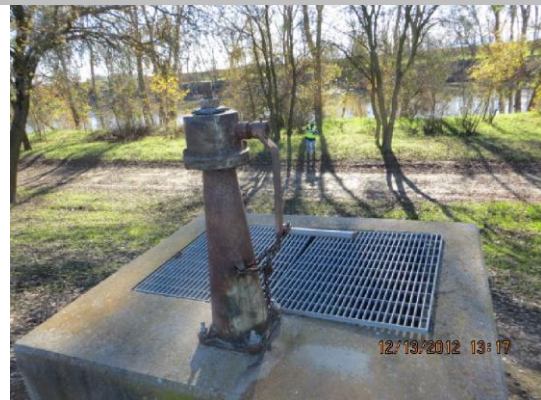
Photo 2 of 2 : UCIP\_FA\_2016\_50635\_47026.jpg

Comment Code					
Inspector Comment					
FS_ID:50635 DS_ID:17309 EP_NO: 9541 Repair Type: Non-Urgent Crossing Status: Found UCIP Comments: 11/7/2016 LS culvert measured to be 30"wide X 30"tall. WS end is not vidible so could not be measured. (DWR Sutter Yard- AFreitag)6/6/2016 Cannot locate the WS headwall/flapgate. Appears to have been silted over.4/6/2015 Same as last inspection. Concrete surg box on WS. Flap gate in concrete "U" headwall at the waterward end- not found.6/30/2014 Same as last inspection.12/30/2013 Same as last inspection.7/29/2013 Same as last inspection. FIELD_STRUCT_DESC: 30-inch reinforced concrete box drainage culvert through the levee, 14.3 feet below the crown. 30-inch corrugated metal pipe connects concrete culvert from slide gate out to flap gate on the waterside (WS) end. Slide gate in a concrete riser on the waterside (WS) slope. (Automatic Board Order (ABO) issued as Permit No. 9541, 1974 - Wilbur, McGowan, Zinke). [Additional Reference(s): DWR Levee Logs, 2002. USACE Sacramento O&M Manual 136, March 1960 (HLM 2.49)]. FS Date: 11/7/2016 2:57:48 PM

Waterside view: overview- concrete surg tank

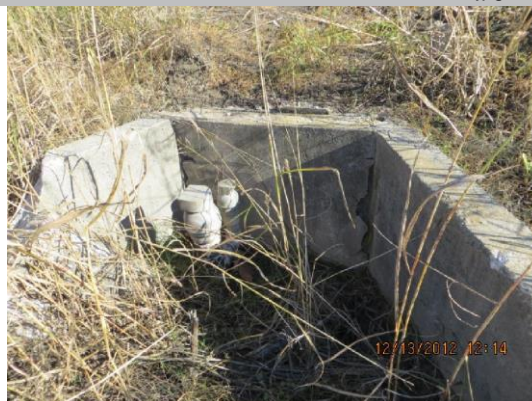
Photo 1 of 2 : UCIP\_FA\_2016\_50639\_47049.jpg

FS\_ID:50639  
DS\_ID:17312  
EP\_NO: 9539  
Repair Type: Urgent  
Crossing Status: Found  
UCIP Comments: 11/7/2016 Nothing has changed with this crossing since the last inspection. The gap between the top of the WS headwall and concrete plug could be a problem with water flow during high water times. (DWR Sutter Yard- A Freitag)6/6/2016 One of the pipes appear to be leaking inside of the concrete culvert. From the WS headwall water can be heard flowing inside of the levee behind the concrete plug. The concrete plug also appears to leak as water current can be seen flowing around it. There is also a 1" gap at the top of the plug and the old WS headwall that will allow high water to flow through uncontrolled. (DWR Sutter Yard - a Freitag)4/6/2015 6-inch and 18-inch pipes still present in crossing and WS end still plugged with concrete. It seems that the system was originally designed for drainage but later converted into an irrigation system. 6-inch GI pipe and 18-inch PVC pipes inserted into culvert from LS (not plugged). WS opening is plugged with concrete. Probably pump is located 350 ft from levee as seen from Google Earth Map. (DWR Sutter Yard - a Freitag)6/30/2014 Same as last inspection. (DWR Sutter Yard - a Freitag)12/30/2013 Same as last inspection. (DWR Sutter Yard - a Freitag)7/29/2013 Same as last inspection. (DWR Sutter Yard - a Freitag)

Waterside view: plugged concrete structure and siphon breakers

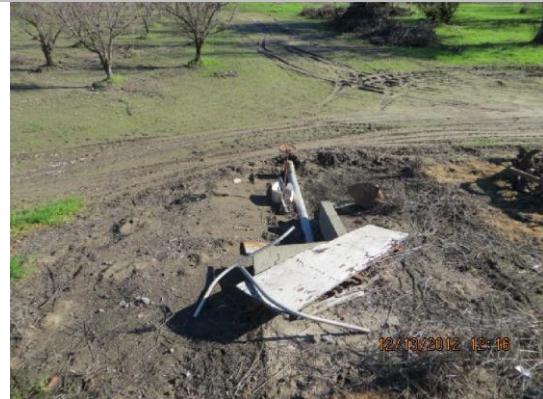
Photo 2 of 2 : UCIP\_FA\_2016\_50639\_47046.jpg

FS\_ID:50639  
DS\_ID:17312  
EP\_NO: 9539  
Repair Type: Urgent  
Crossing Status: Found  
UCIP Comments: 11/7/2016 Nothing has changed with this crossing since the last inspection. The gap between the top of the WS headwall and concrete plug could be a problem with water flow during high water times. (DWR Sutter Yard- A Freitag)6/6/2016 One of the pipes appear to be leaking inside of the concrete culvert. From the WS headwall water can be heard flowing inside of the levee behind the concrete plug. The concrete plug also appears to leak as water current can be seen flowing around it. There is also a 1" gap at the top of the plug and the old WS headwall that will allow high water to flow through uncontrolled. (DWR Sutter Yard - a Freitag)4/6/2015 6-inch and 18-inch pipes still present in crossing and WS end still plugged with concrete. It seems that the system was originally designed for drainage but later converted into an irrigation system. 6-inch GI pipe and 18-inch PVC pipes inserted into culvert from LS (not plugged). WS opening is plugged with concrete. Probably pump is located 350 ft from levee as seen from Google Earth Map. (DWR Sutter Yard - a Freitag)6/30/2014 Same as last inspection. (DWR Sutter Yard - a Freitag)12/30/2013 Same as last inspection. (DWR Sutter Yard - a Freitag)7/29/2013 Same as last inspection. (DWR Sutter Yard - a Freitag)

Landside view: overview- concrete culvert and pipes

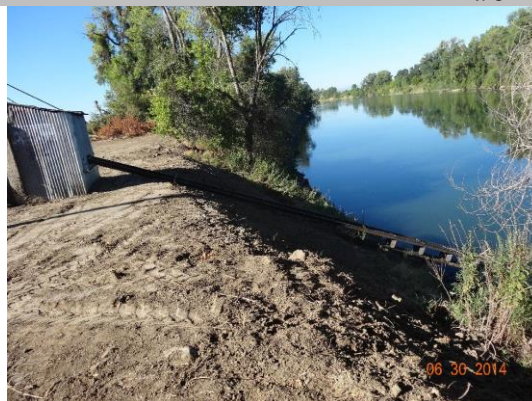
Photo 1 of 2 : UCIP\_FA\_2016\_50797\_71480.jpg

FS\_ID:50797  
DS\_ID:17314  
EP\_NO: 9501-1  
Repair Type: Non-Urgent  
Crossing Status: Found  
UCIP Comments: 11/7/2016 Crossing appears to be in good condition. (DWR Sutter Yard- A Freitag)6/17/2016 DO NOT BELIEVE THIS IS AN ABANDONED CROSSING- there is a newer looking pump present inside the WS pump house with an active PG&E power meter. Also the dirt below the siphon breaker inside of the riser on the LS shoulder was wet indicating that the breaker has had running water through it recently. Also the ground under the LS toe airvent was wet indicating that it too has recently had water flowing through it. 4/4/2016 Concrete box on LS still silted in. Cracking and slope failure previously cited appears to have been repaired as we could not locate. Shutoff valves appear in good condition. If crossing is abandoned, should be done so properly. 4/6/2015 Same as last inspection. Concrete pit on WS berm. Concrete distribution box on LS silted and erosion around the box. Slope failure/ transverse cracks on LS levee slope. Two depressions on WS berm. 6/30/2014 Crossing appears to be being made active again. WS bank has been cleared of all vegetation and debris to allow pump to slide down to water level. New shutoff valve installed on WS shoulder inside of cmp stand pipe. New air-vac installed inside cmp standpipe on LS shoulder and air vent installed on LS toe. Could not Locate pipe end on LS. Need to check for permit number for work done. 12/30/2013 Repairs to LS and WS slopes have been completed. Not sure if this is an active or abandoned crossing. LS distribution box is still silted in. 7/29/2013 Repairs to LS slope and pipe are in progress. Nothing has been done yet to the WS depressions.

FIELD\_STRUCT\_DESC: 16-inch asphalt coated steel irrigation pipe through the levee, 2 feet below the crown. Pump house over concrete pit on the waterside (WS) berm. A 16-inch gear-operated butterfly valve inside riser with cover off the WS shoulder. Siphon breaker inside riser with cover off the landside (LS) shoulder. Discharges into a concrete box at the LS toe. (Permit No. 9501-1, 2014 - Howard). This pipe was a replacement for an existing (failed) 16-inch pipe under DSID 25455, referenced in the Levee Log and replaced under Permit No. 9501-1. [Additional Reference(s): DWR Levee Log, 2002]. The Levee Log references this pipe's appurtenances along with the original 16-inch under DSID 25455.  
FS Date: 11/21/2016 7:27:09 AM

WS river bank

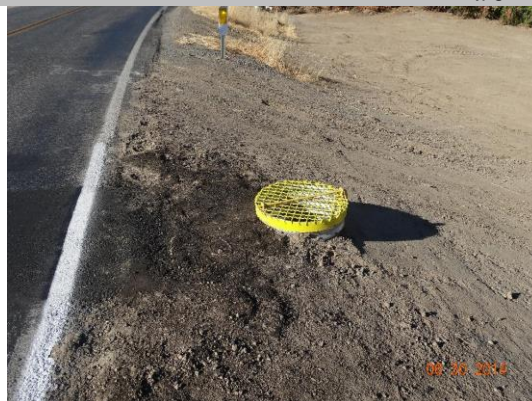
Photo 2 of 2 : UCIP\_FA\_2016\_50797\_71479.jpg

FS\_ID:50797  
DS\_ID:17314  
EP\_NO: 9501-1  
Repair Type: Non-Urgent  
Crossing Status: Found  
UCIP Comments: 11/7/2016 Crossing appears to be in good condition. (DWR Sutter Yard- AFreitag)6/17/2016 DO NOT BELIEVE THIS IS AN ABANDONED CROSSING- there is a newer looking pump present inside the WS pump house with an active PG&E power meter. Also the dirt below the siphon breaker inside of the riser on the LS shoulder was wet indicating that the breaker has had running water through it recently. Also the ground under the LS toe airvent was wet indicating that it too has recently had water flowing through it. 4/4/2016 Concrete box on LS still silted in. Cracking and slope failure previously cited appears to have been repaired as we could not locate. Shutoff valves appear in good condition. If crossing is abandoned, should be done so properly.4/6/2015 Same as last inspection. Concrete pit on WS berm. Concrete distribution box on LS silted and erosion around the box. Slope failure/ transverse cracks on LS levee slope. Two depressions on WS berm.6/30/2014 Crossing appears to be being made active again. WS bank has been cleared of all vegetation and debris to allow pump to slide down to water level. New shutoff valve installed on WS shoulder inside of cmp stand pipe. New air-vac installed inside cmp standpipe on LS shoulder and air vent installed on LS toe. Could not Locate pipe end on LS. Need to check for permit number for work done.12/30/2013 Repairs to LS and WS slopes have been completed. Not sure if this is an active or abandoned crossing. LS distribution box is still silted in.7/29/2013 Repairs to LS slope and pipe are in progress. Nothing has been done yet to the WS depressions.

FIELD\_STRUCT\_DESC: 16-inch asphalt coated steel irrigation pipe through the levee, 2 feet below the crown. Pump house over concrete pit on the waterside (WS) berm. A 16-inch gear-operated butterfly valve inside riser with cover off the WS shoulder. Siphon breaker inside riser with cover off the landside (LS) shoulder. Discharges into a concrete box at the LS toe. (Permit No. 9501-1, 2014 - Howard). This pipe was a replacement for an existing (failed) 16-inch pipe under DSID 25455, referenced in the Levee Log and replaced under Permit No. 9501-1. [Additional Reference(s): DWR Levee Log, 2002]. The Levee Log references this pipe's appurtenances along with the original 16-inch under DSID 25455.  
FS Date: 11/21/2016 7:27:09 AM

WS standpipe with shut off valve inside

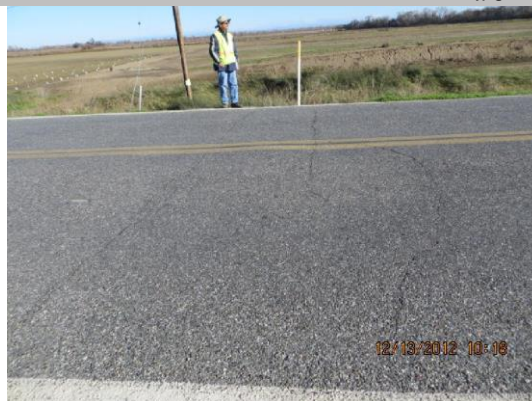
Photo 1 of 2 : UCIP\_FA\_2016\_50801\_47068.jpg

Crown view: transverse cracks on levee road.

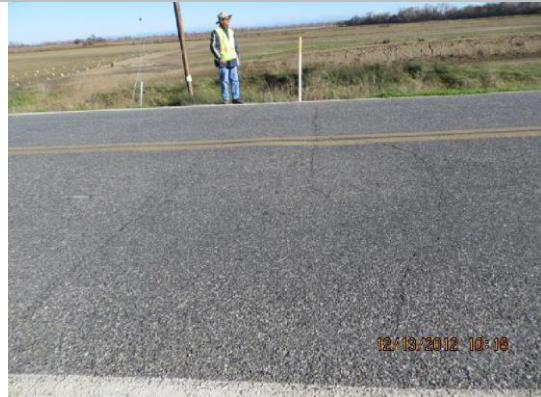
Photo 1 of 2 : UCIP\_FA\_2016\_50802\_47080.jpg

LM Start	<b>4.44</b>	Rating **	U	Issue No.	<b>143 (cont)</b>
LM End	<b>4.44</b>	Issue Type +	En	Location *	WS

Crown view: cracks along pipe alignment (transverse crack)

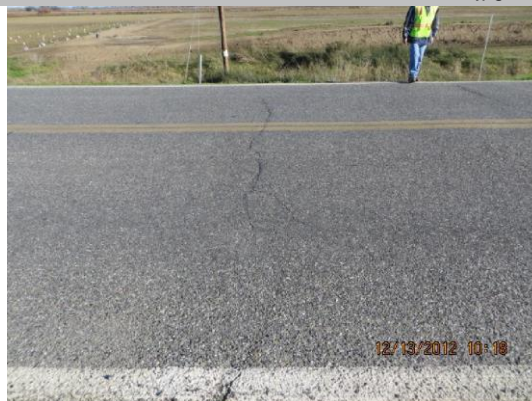
Photo 1 of 2 : UCIP\_FA\_2016\_50803\_47087.jpg

Crown view: transverse crack on levee road

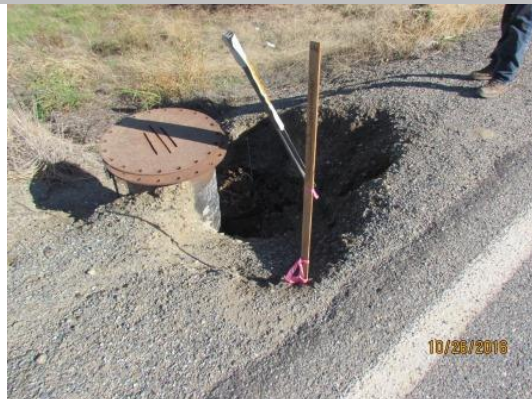
Photo 1 of 1 : FA\_2016\_ST0003\_264\_106\_20161104\_00127.jpg

View of the erosion next to a pipe along the landside slope.

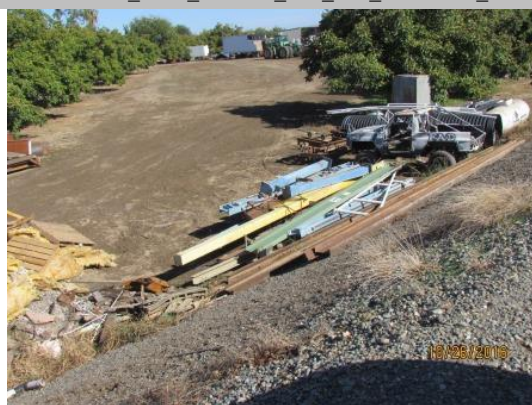
Photo 1 of 1 : FA\_2016\_ST0003\_264\_100\_20161104\_00130.jpg

View of the ag equipment along the landside toe.

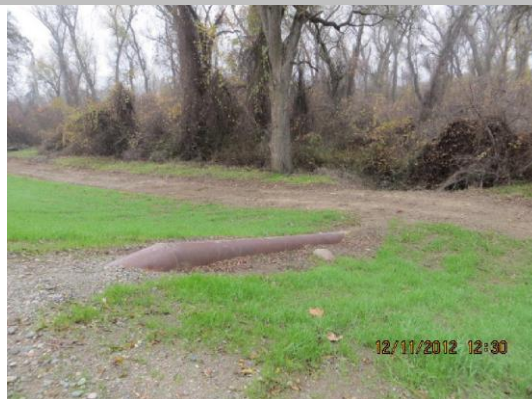
Photo 2 of 2 : UCIP\_FA\_2016\_50573\_47283.jpg

Waterside view: overview of exposed steel pipe

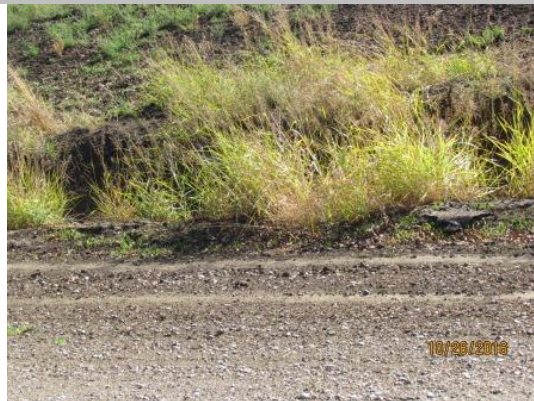
Photo 1 of 1 : FA\_2016\_ST0003\_264\_6\_20161104\_00135.jpg

View of the ditch along the landside toe.

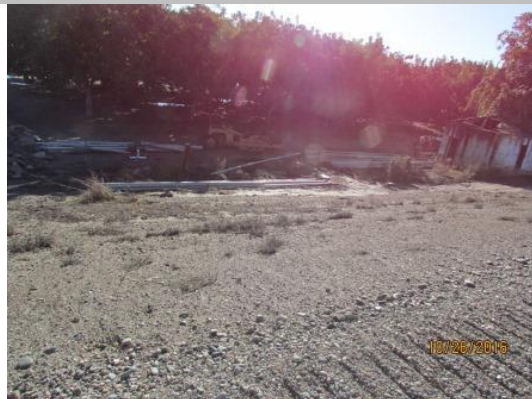
Photo 1 of 1 : FA\_2016\_ST0003\_264\_76\_20161104\_00136.jpg

View of the ag equipment along the landside toe.

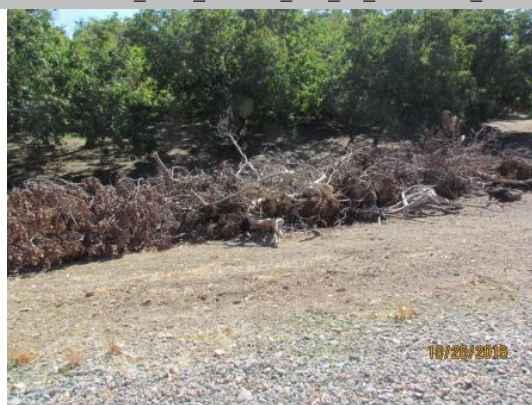
Photo 1 of 1 : FA\_2016\_ST0003\_264\_68\_20161104\_00141.jpg

View of the prunings along the landside toe.

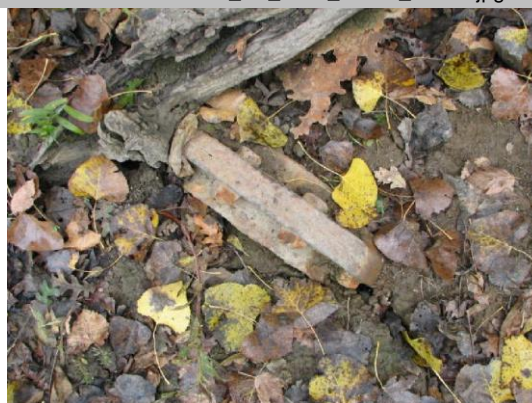
Photo 2 of 2 : UCIP\_FA\_2016\_50612\_47448.jpg

Waterside view: abandoned and ruined pipe

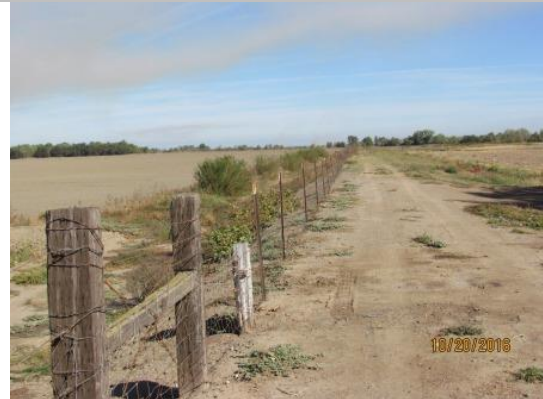
Photo 1 of 1 : FA\_2016\_ST0003\_268\_1\_20161104\_00002.jpg

View of the fence obstructing access.
